Technical Bulletin

Water Intrusion Prevention and H-00276 Harness Replacement

Connector Damage and Water Intrusion Prevention to Protect the Purkeys P1020-K Liftgate Charging Plate Assembly in the Liftgate Battery Box

Replacing the H-00276 Harness for the Purkeys P1020-K Liftgate Charging Plate Assembly

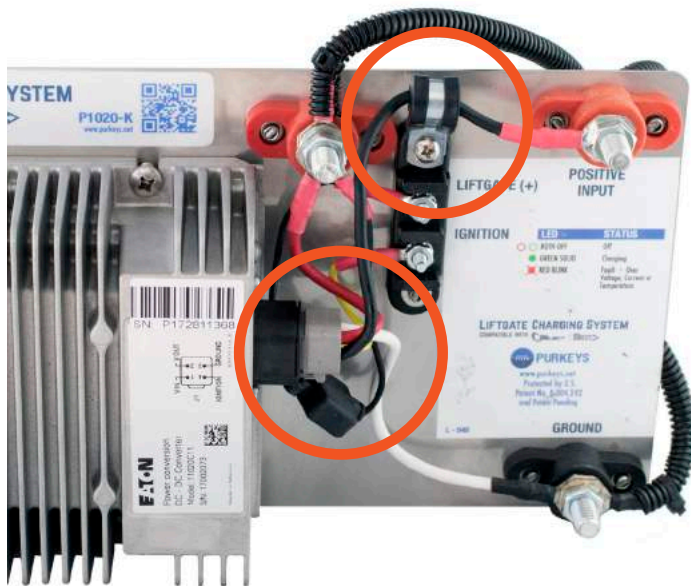
Before water intrusion prevention:

Purkeys has recently noticed that certain customers may experience water intrusion in the liftgate battery box or see damage to the connector that plugs into the DC/DC converter, either of which may electrically short the connection to the DC/DC converter.

To prevent electrical shorts due to water intrusion, remove the rubber clamp (see photos on the following page) and allow the black wire to form a drip loop so that water will not enter the connector to the converter.

We also recommend installing a zip tie around the 4 wires at the connector (see photos on the following page) and allow the tail of the zip tie to point downward, creating a secondary drip path for water.

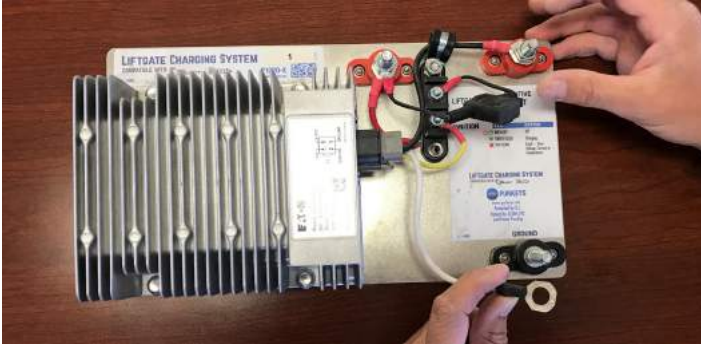
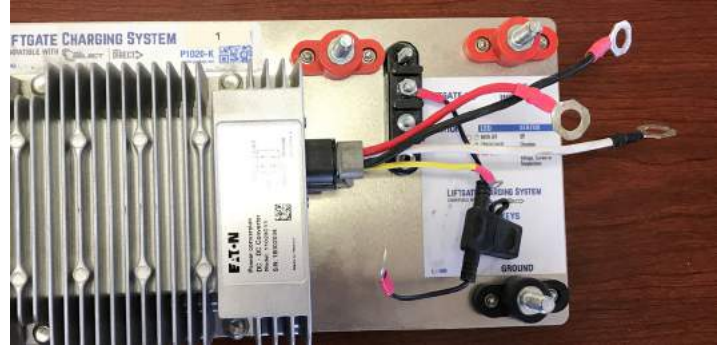
Step 1: Remove the nuts from the bolts connecting the harness ring terminals to the plate.

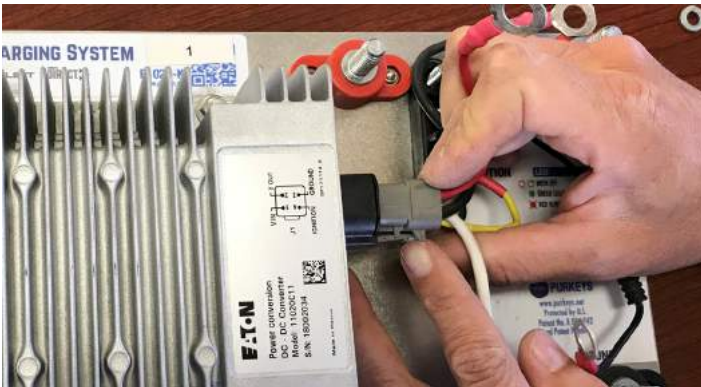
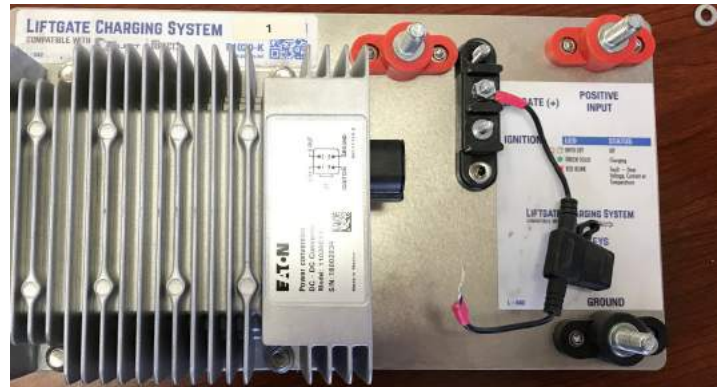
Step 2: Press the clip on the side of the connector and remove.

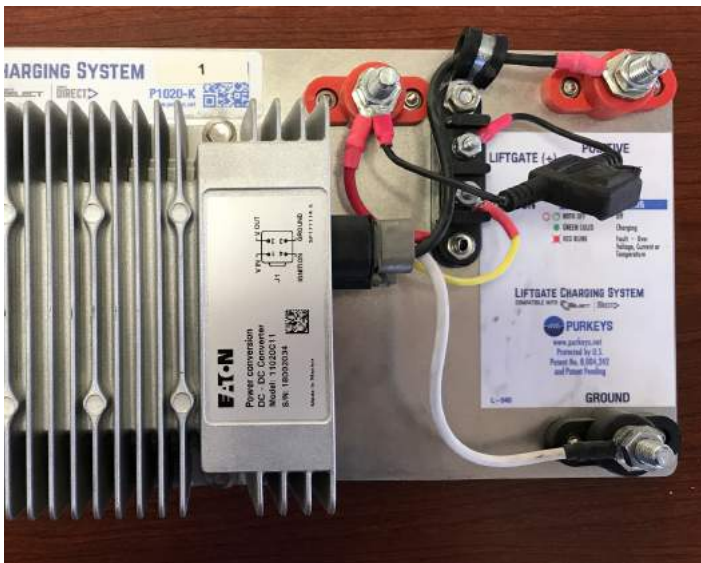
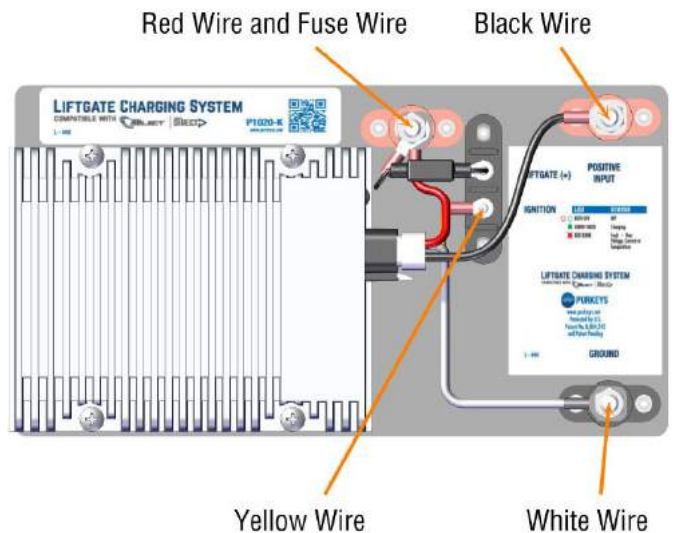
Step 3: Install the new harness by inserting the connector and securely attaching each ring terminal to the plate with the nuts removed in Step 1.
